ESL-TR-80-45

FLUSH AM-2 MAT PATCH FOR RAPID RUNWAY REPAIR

JAMES L. GREENE

SEPTEMBER 1980

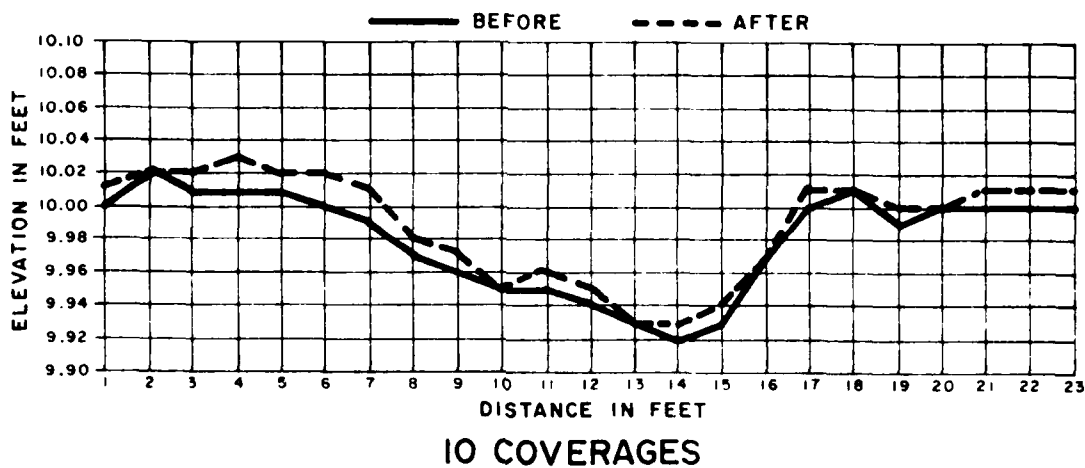
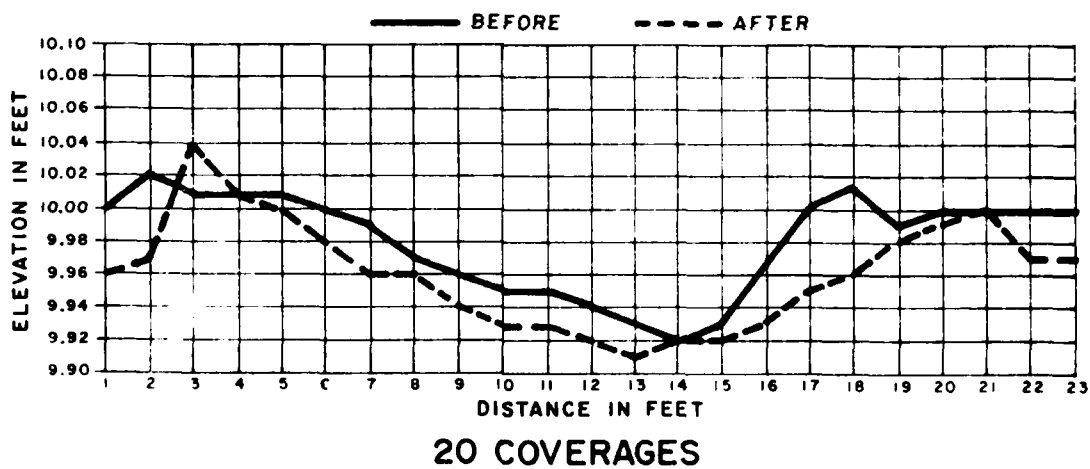
Figure 23. Coverages on Z-Clip System, C-141 Aircraft, Base Line B-B

Trafficking with the C-141 load cart began. After ten coverages the previous repair had completely spalled out. After 20 coverages spalling was much worse and a large deflection of the patch under load was noted.

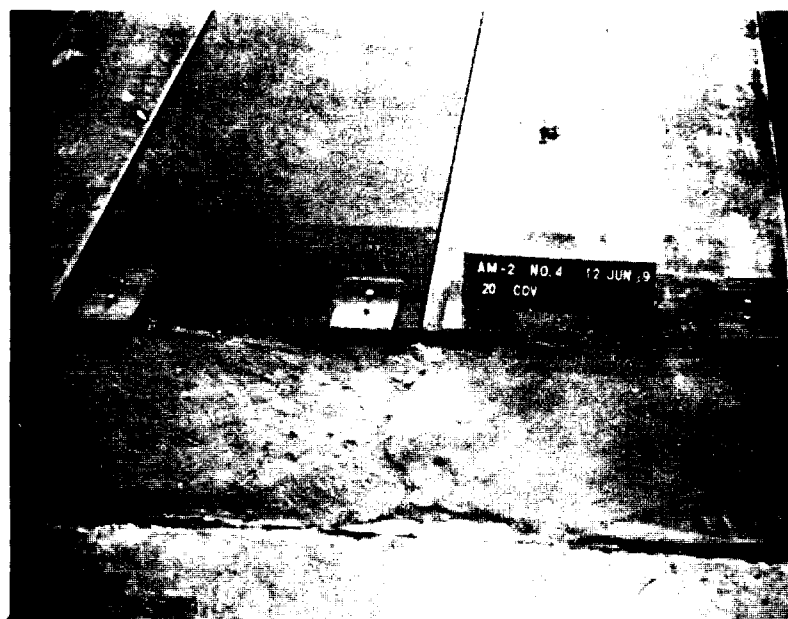
- (1) 10 Coverages: Several of the clips had pulled loose from the panels. Maximum separation was 1/4 inch.
- (2) 20 Coverages: A few hairline cracks were noted around the inside edge of the Silikal®.

Figure 36. Test 1 (Z-Cl 15)-20 Coverages of F-4

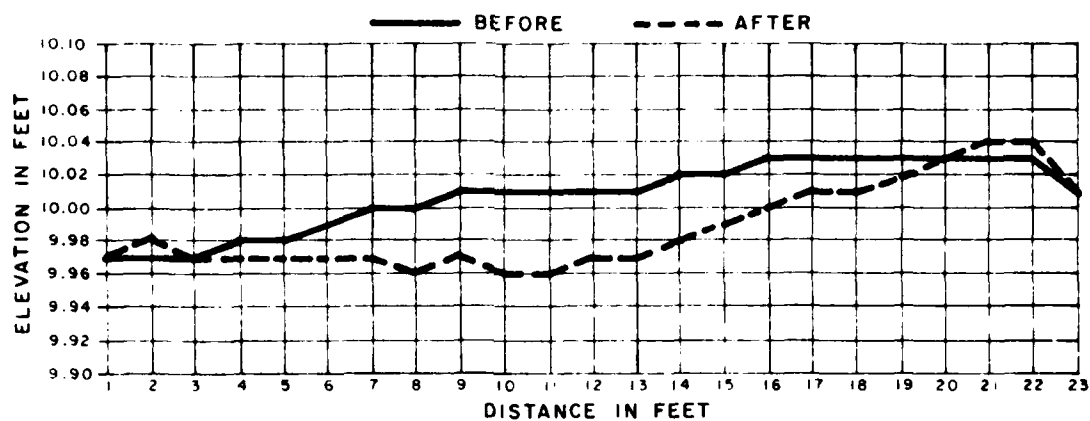
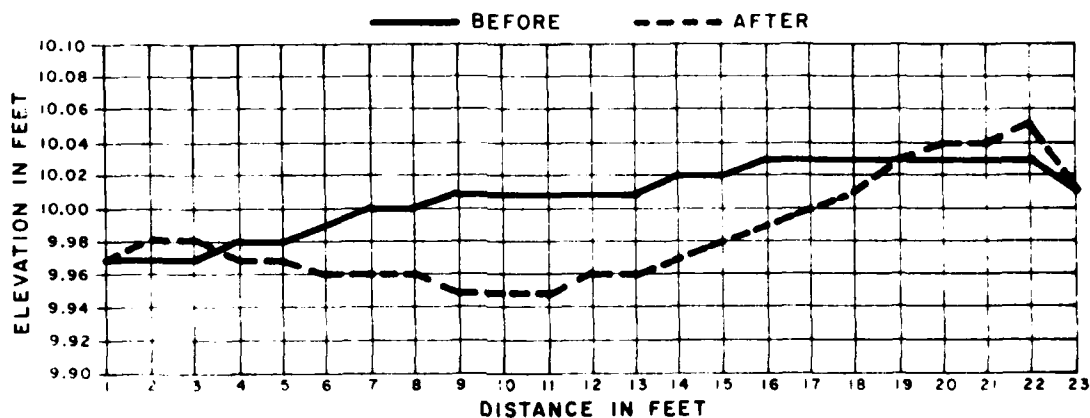
Figure 45. Coverages on Perimeter Rail System, F-4 Aircraft, Base Line C-C

It was apparent immediately after trafficking began with the F-4 load cart that this system was weak. The rail, resting directly on the subgrade, settled after a few coverages causing the load cart to bounce as it came on or off the patch. This also exposed the sharp edge of the concrete posing possible damage to the F-4 tire. It was noted that after 20 coverages there were several short tears where the extrusion was welded to the ends of the panels. There was about a one inch lip at the edge of the concrete. Failure was determined at 60 coverages due to the amount of deflection of the rail and the resulting possibility of tire damage. Since failure occurred in the early stages of testing with the F-4, the C-141 trafficking was not accomplished.

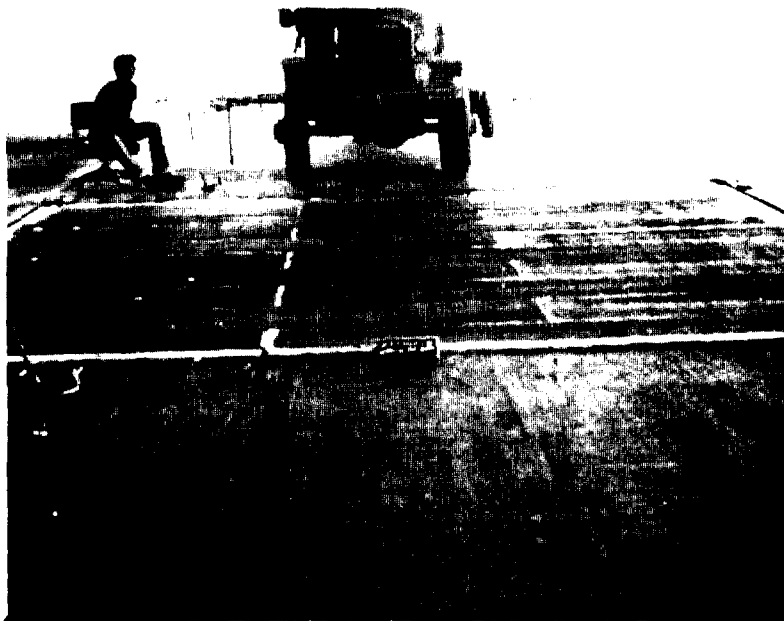
Figure 53. Test 2 (Perimeter Rail)-
20 Coverages of F-4

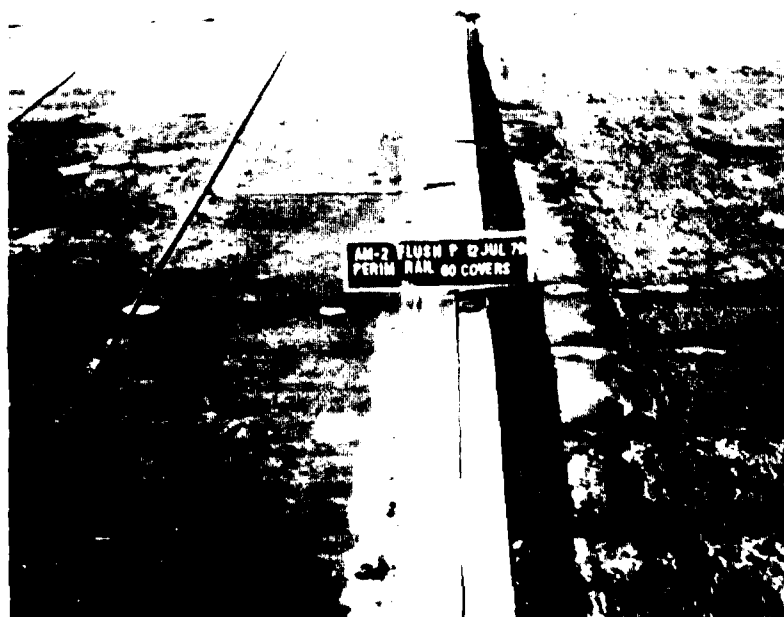
Figure 54. Test 2 (Perimeter Rail)-
60 Coverages of F-4

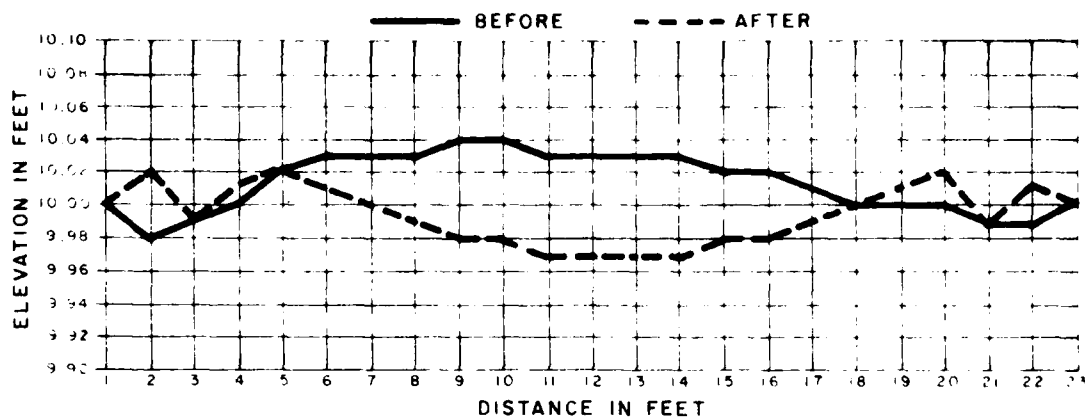
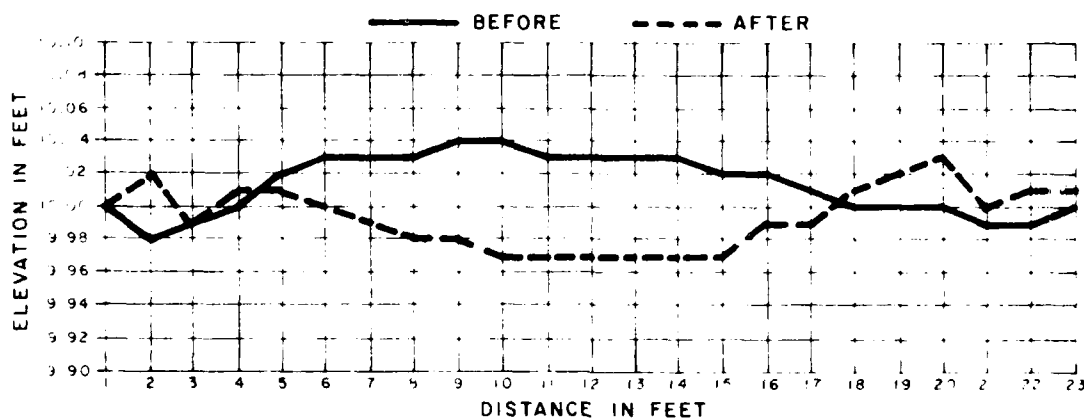
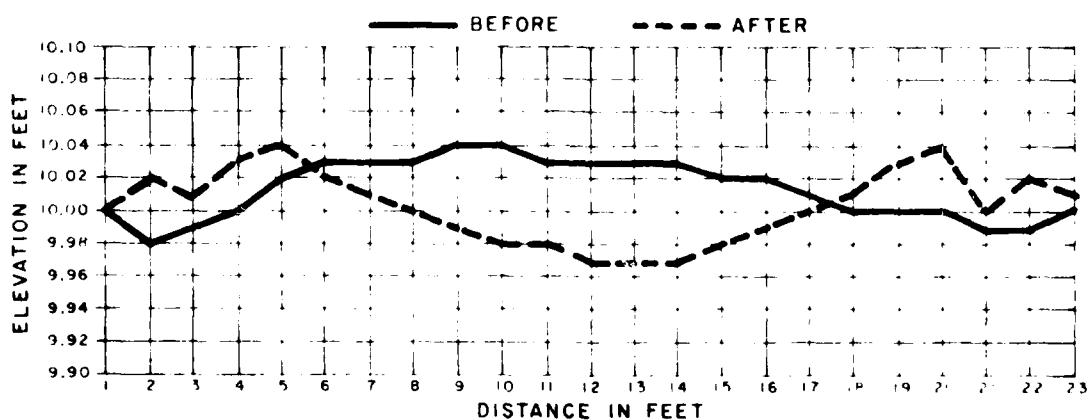
Figure 57. Coverages on Side Panel System, F-4 Aircraft and C-141 Aircraft, Base Line A-A

After six coverages of the F-4, it appeared the nails were beginning to loosen as deflection was noted in the locking assembly as the load cart passed. Several times during trafficking, an angle would come loose. This could have been prevented by making the projection on the angle longer so that it would not slip from the locking assembly when the assembly deflects under load. At 40 coverages the inside plate on the locking assembly was beginning to permanently bend towards the center of the pit. A total of 150 coverages of the F-4 were completed with only minor problems encountered.

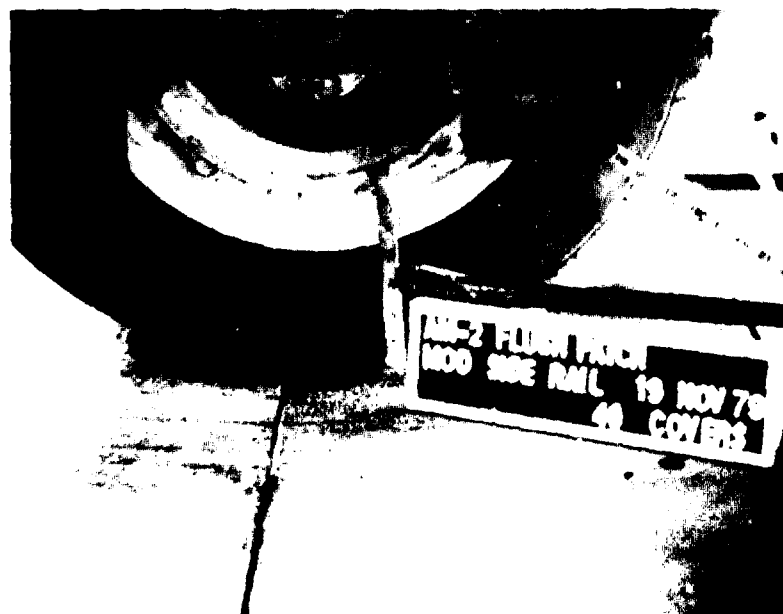
Figure 87. Test 4 (Modified Side Panel)-
40 Coverages of F-4

Considerable consolidation was noted after ten coverages of the F-4 load cart. The side angles were bending towards the center and, as a result, bending the back plate of the locking assembly. After 20 coverages the nails were beginning to pull out. It appeared the base course was being pushed out of the traffic lane and mounding on the sides. At 40 coverages the angle and assembly were experiencing considerable deflections, indicating the nails had pulled out of the concrete. This caused the load cart to bounce as it came off the edge of the concrete. Sufficient deflection had taken place at 60 coverages that the patch was determined to have failed. Observations made during removal of the patch are as follows:

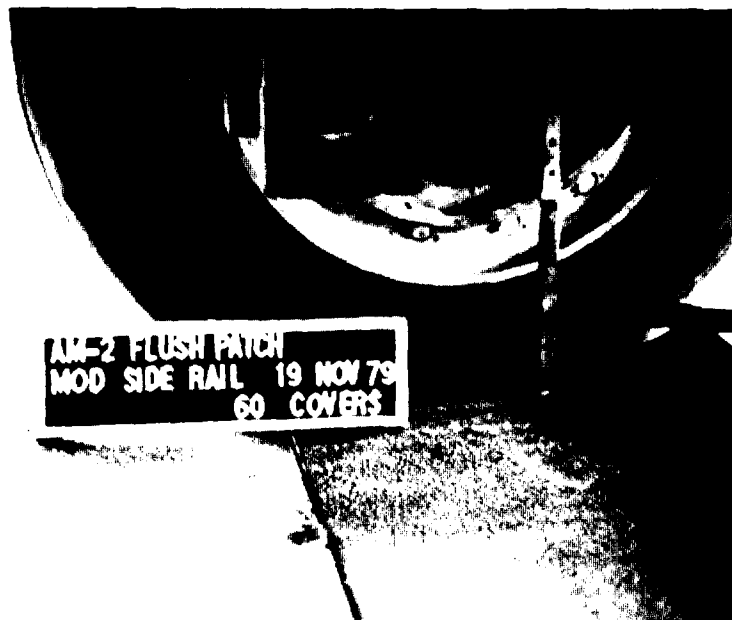
Figure 88. Test 4 (Modified Side Panel)-
60 Coverages of F-4

- (1) The locking assembly was bent considerably in the traffic lane allowing the angle to be easily removed.
- (2) The base course in the traffic lane was well compacted; however, outside the traffic lane the material was very loose.
- (3) The nails in the traffic lane had broken loose.
- (4) The 1/4-inch projection came off the angles as they were being removed.
